AFML-TR-76-81-PT-4

DEFECT-PROPERTY RELATIONSHIPS IN COMPOSITE MATERIALS

K. L. Reifsnider, E. G. Herneke, II and W. W. Stinchcomb

Final Report

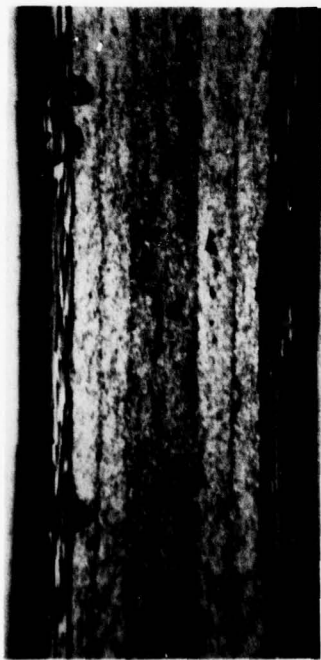
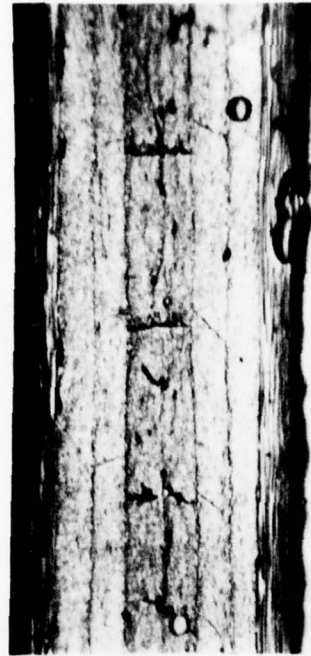
In the case of both Type I and Type II specimens, damage in the form of transverse cracking appears first. In both cases, it appears first in  $90^\circ$  laminae, i.e., the lamina whose fibers are perpendicular to the load axis or the lamina with the lowest strength along the load axis. Initially, these transverse cracks are arrested at the lamina interfaces, and do not propagate to adjacent plies. With increasing load, cracks appear for a time almost solely in these  $90^\circ$  laminae. Stated differently, the general trend is for the damage pattern to develop along the entire length of the specimen rather than through the laminate thickness to adjacent lamina. From this point on, however, the sequence of events differs for the two stacking sequences. In Type I  $[0, \pm 45, 90]_s$  laminates, as load increases, the number of transverse cracks in the  $90^\circ$  lamina increases until a constant or saturation spacing is reached. These transverse cracks extend continuously across both  $90^\circ$  lamina and initially stop at the  $90^\circ/-45^\circ$  lamina interfaces (Fig. 1A, B, C).

Figure 1. Crack Patterns in Type I Laminates

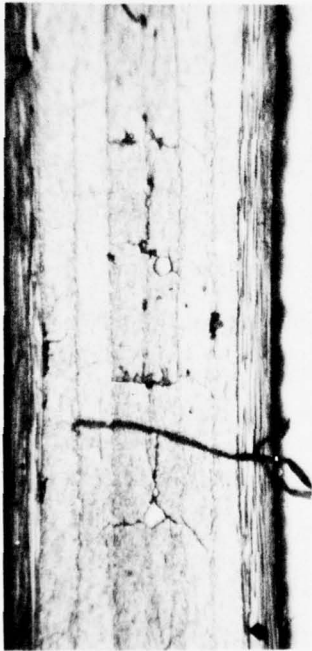
Figure 1. (cont'd) Crack Patterns in Type I Laminates

Having described the general sequence of events leading to failure and introduced the concepts of saturation spacing and a characteristic damage state (Figs. 1D, E and 2G), we will now look more closely at the details of the physical behavior. In the interest of presenting data in its most useful and meaningful context, information defining the observed characteristic damage states will be reported in terms of crack spacing. This can be interpreted, physically, as the average distance between transverse cracks when the whole length of the lamina is examined. These distances were determined by dividing the lamina length by the total number of transverse cracks observed in a given lamina. These values were obtained by scanning the replicas of specimen edges and counting the number of transverse cracks in each lamina. These numbers will, of course, be identical for the center two laminae ( $-45^\circ$  plies for Type II material and  $90^\circ$  plies for Type I material) since cracks in these lamina extend across both plies. However, values obtained for each  $+45^\circ$  and  $-45^\circ$  (Type I) lamina and each  $90^\circ$  and  $-45^\circ$  lamina will generally differ slightly. In those laminae we were monitoring damage in two "identical" plies symmetrically positioned about the laminate midplane. To simplify the data presentation, the average of those two values was used in subsequent calculations. The validity of this operation is seen when Figs. 3 and 4 are examined. Figures 3 and 4 show the total number of cracks over the 75 mm (3 in) gage length in each  $90^\circ$  lamina of specimen 2652-14 (edges I and II respectively) at low stress levels. These figures show the crack development in each  $90^\circ$  lamina to be quite constant; indeed, they coincide at several stress levels.

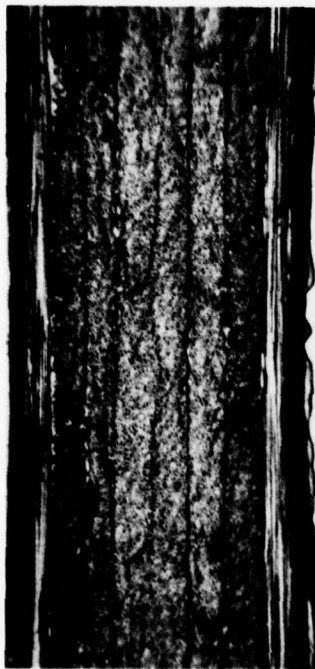
A

Damage in the Type II  $[0,90,+45]_S$  specimens again begins in the form of transverse cracks in the  $90^\circ$  lamina. Again they initially span only the  $90^\circ$  lamina and do not cross the  $90^\circ/+45^\circ$  interfaces, as shown in Fig. 2A. These cracks become much more numerous than the transverse cracks in the Type I material, i.e., the saturation spacing is much smaller (0.332 mm average for 6 Type II specimens vs 0.735 mm average for 5 Type I specimens). The  $90^\circ$  lamina are not adjacent in this stacking sequence and constraint on the  $90^\circ$  lamina is also much greater (the adjacent lamina have  $0^\circ$  and  $+45^\circ$  orientations as opposed to  $-45^\circ$  and  $90^\circ$  orientations in the Type I material). The stiffer plies surrounding the  $90^\circ$  plies transfer the stress back into the  $90^\circ$  ply over a shorter distance above and below a crack than for the type I laminate causing the next crack

Figure 2. Crack Patterns in Type II Laminates

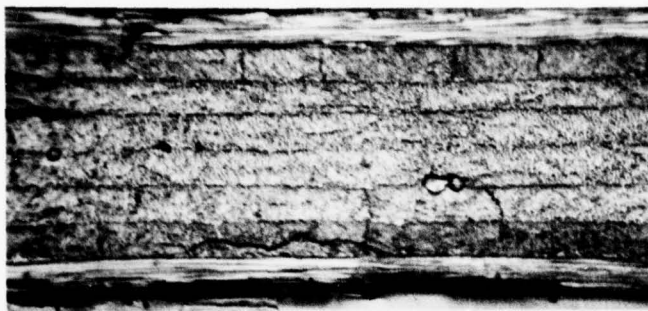
E

Figure 2. (cont'd) Crack Patterns in Type II Laminates

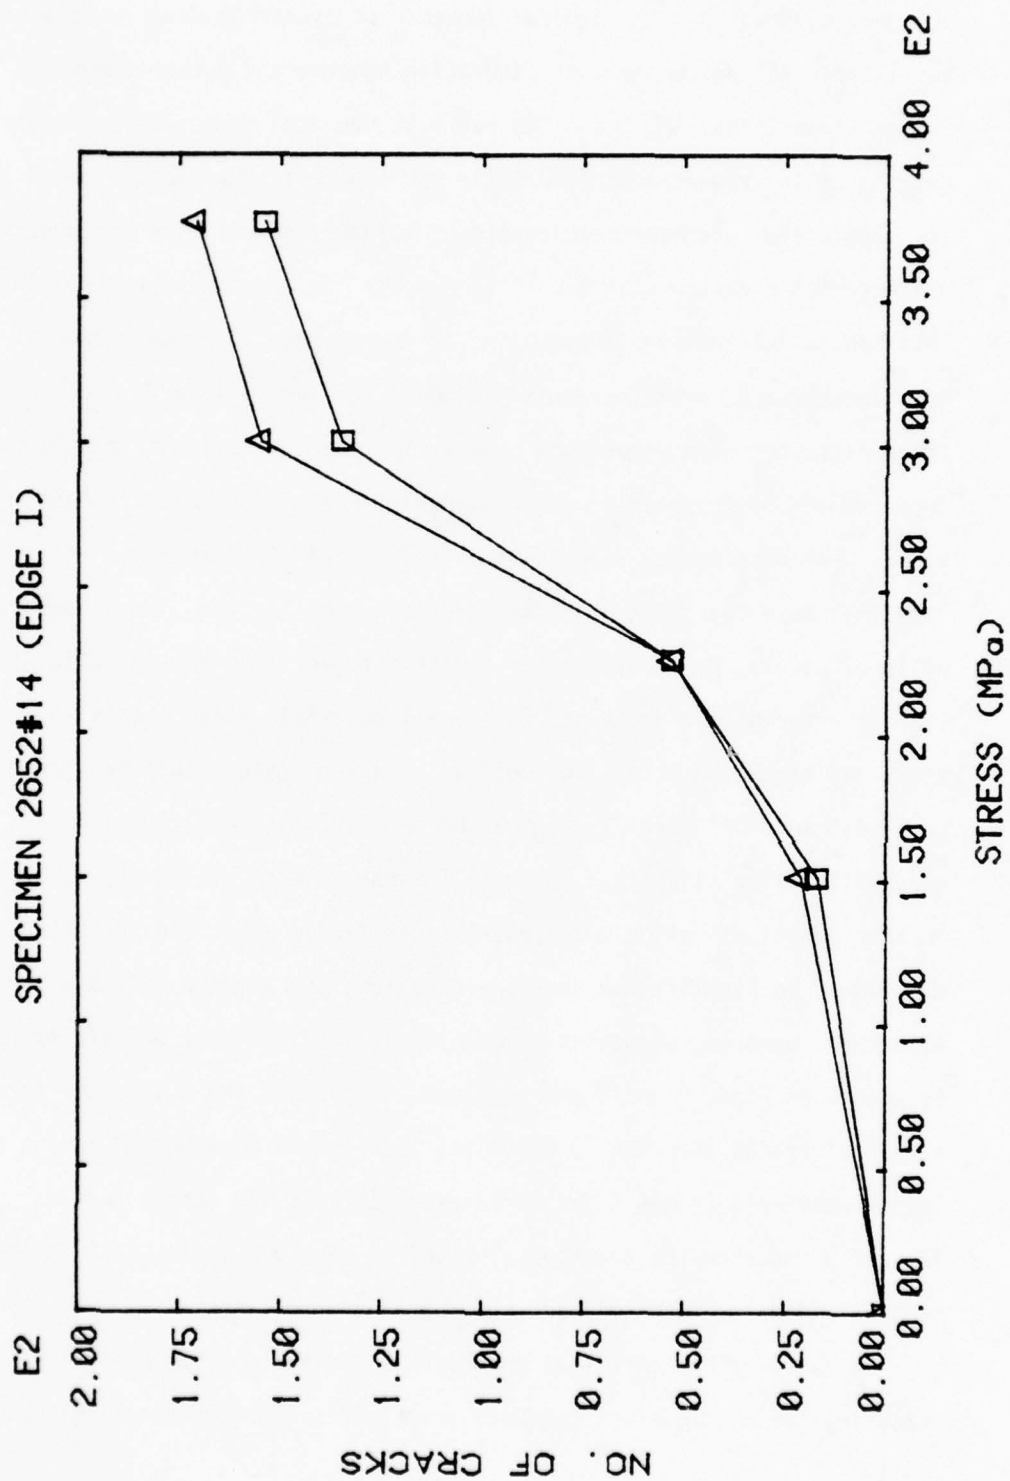
Figure 3. Number of Cracks Observed in each 90° Lamina at Edge I of Type II Specimen 2652#14

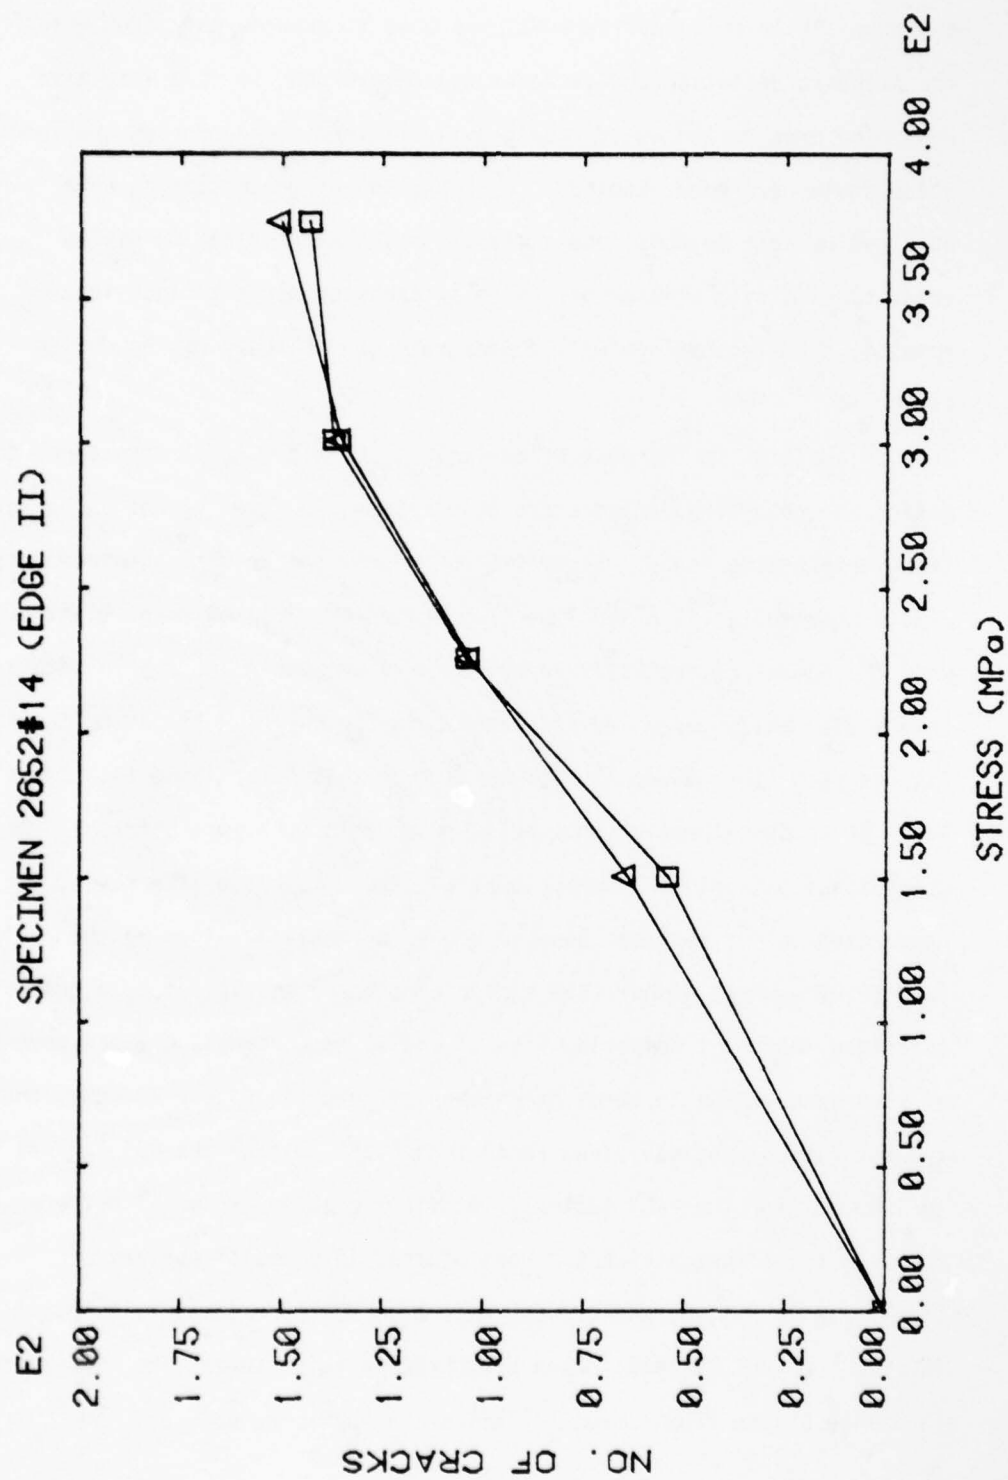
Figure 4. Number of Cracks Observed in each 90° Lamina at Edge II of Type II Specimen 2652#14

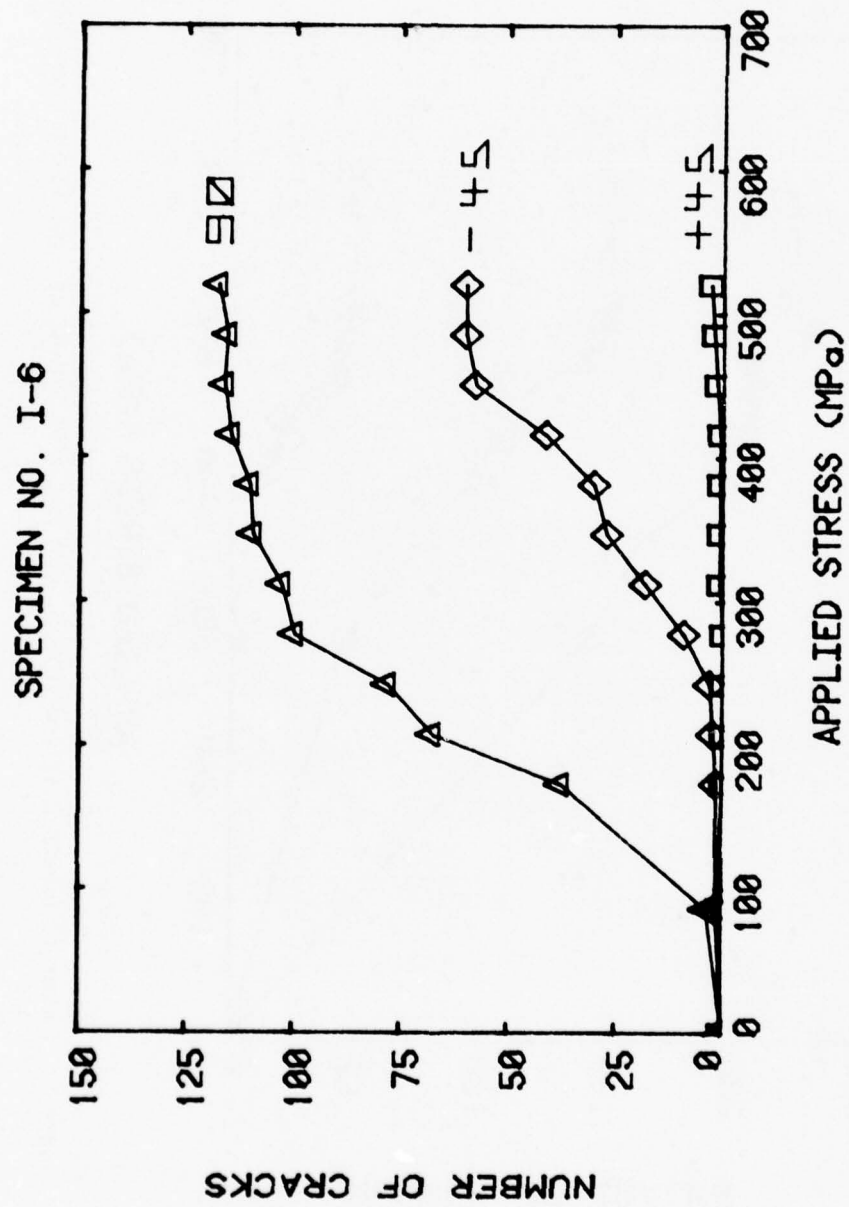
In addition to the ease of operation, there are other advantages to making and reporting damage state observations in terms of the number of transverse cracks found. Figures 5 and 6 show the results obtained for Type I specimen No. I-6 and Type II specimen No. 2652-10 respectively. When the number of cracks is reported in this manner, the stable saturation levels are easily perceived as plateaus in the curves. Comparing these figures with Figs. 8 and 12, it can be seen that determining the stress level at which saturation spacing is reached is much more difficult when crack spacing is plotted versus applied stress. In the later case, the resolution is not as great because we are essentially plotting the inverse of a whole number (the number of cracks) multiplied by a constant (specimen length). Comparing Figs. 7 and 12 also reveals another advantage of recording damage in terms of numbers of cracks. Figure 12 shows that the saturation spacing values range from 0.385 mm (for the 90° lamina) to 1.65 mm (for the -45° lamina). At first glance, the small difference may seem to be insignificant. When plotted in terms of numbers of cracks, as in Fig. 6, the values range from 204 (for the 90° lamina) to 46 (for the -45° lamina). When presented in this manner, the differences in damage states from lamina to lamina are much more obvious.

Figure 5. Number of Cracks Observed in 90°, +45° and -45° Lamina of Type I Specimen I-6

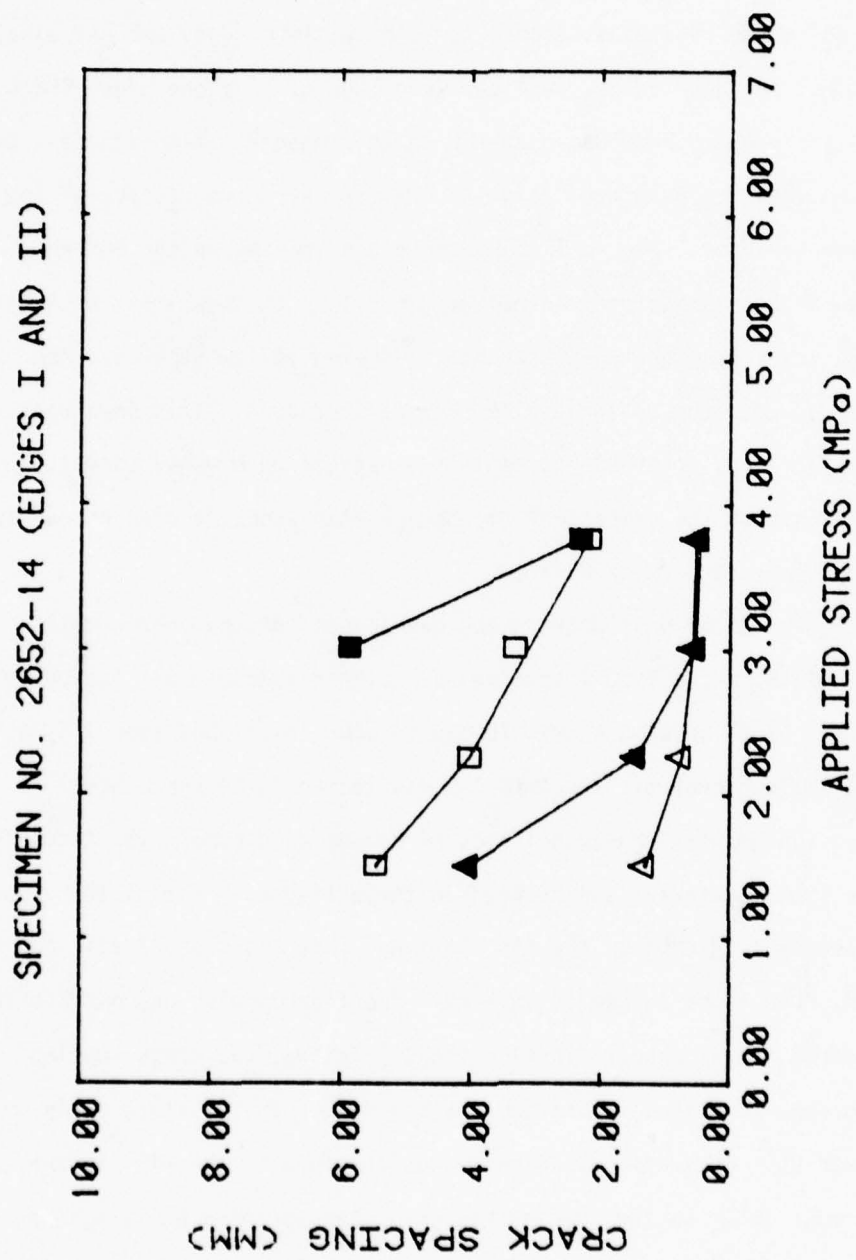
Figure 7. Average Crack Spacing in 90° and +45° Laminates for Edges I and II of Specimen 2652-14

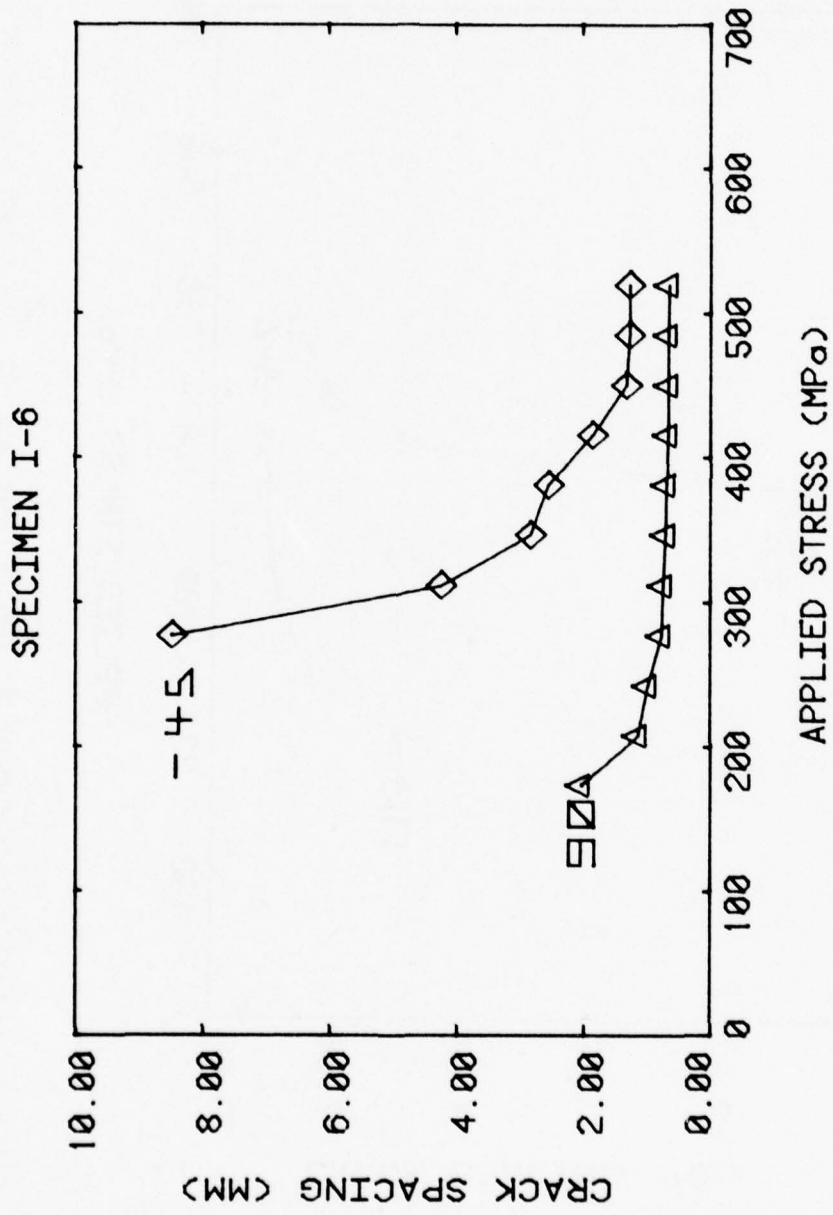
Figures 8 and 9 illustrate the development of the characteristic damage state in two Type I specimens. Neither specimen was loaded to failure. (Both specimens were loaded to 3000 lbs.) Specimen I-6 was tested in load control; specimen I-9 was tested in stroke control. Several fundamental characteristics of damage development in statically loaded Type I material can be seen in these figures. First, there was no appreciable damage in the  $+45^\circ$  lamina. This was true of all specimens tested, even those loaded to failure. The figures also demonstrate that transverse cracks appear first in the  $90^\circ$  lamina, and crack spacing values near the final saturation spacing values are attained early in the loading. Saturation spacing is not attained in the  $-45^\circ$  lamina until much later in the loading history. For specimen No. I-6, the final saturation value of 0.664 mm was first reached at 415 MPa but at

Figure 8. Average Crack Spacings in 90° (bottom curve) and -45° (top curve) Lamina for Specimen No. I-6

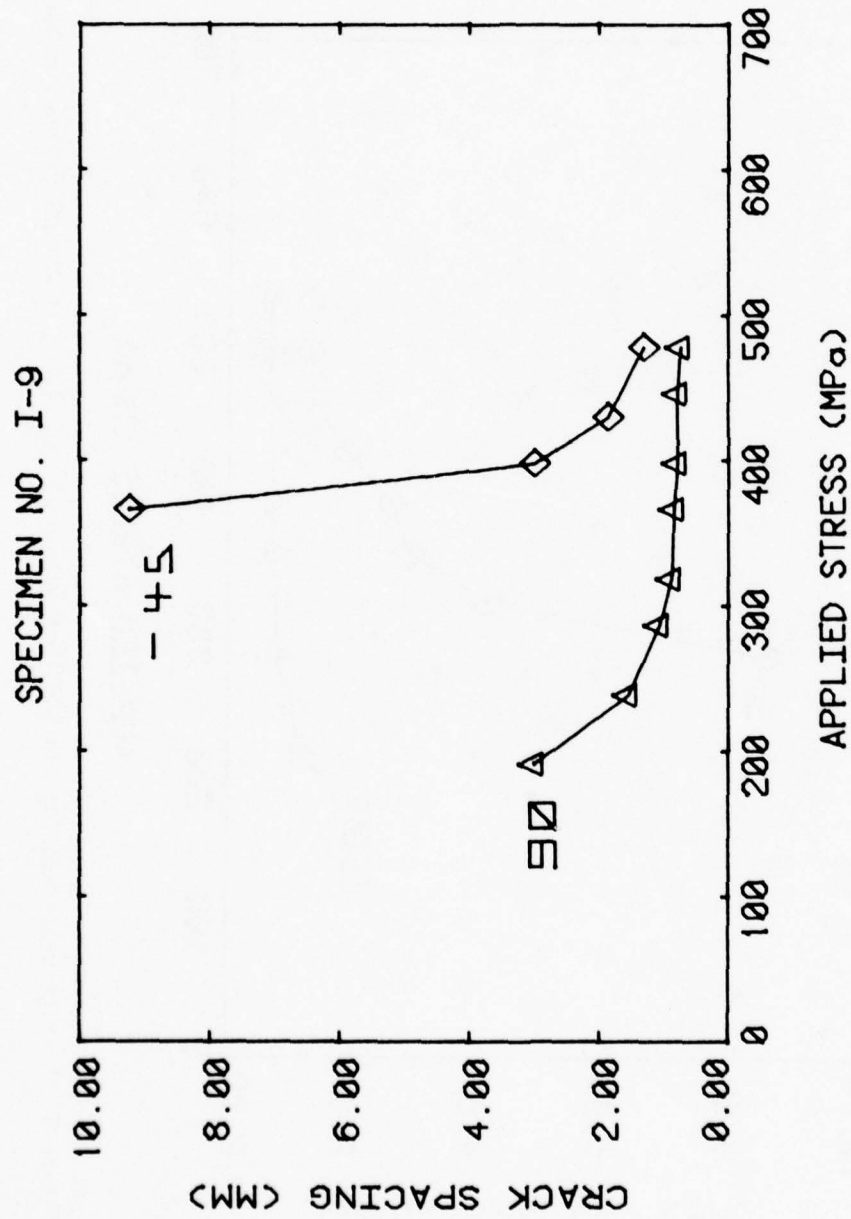
Figure 9. Average Crack Spacing in 90° (bottom curve) and -45° (top curve) Laminae for Specimen No. I-9

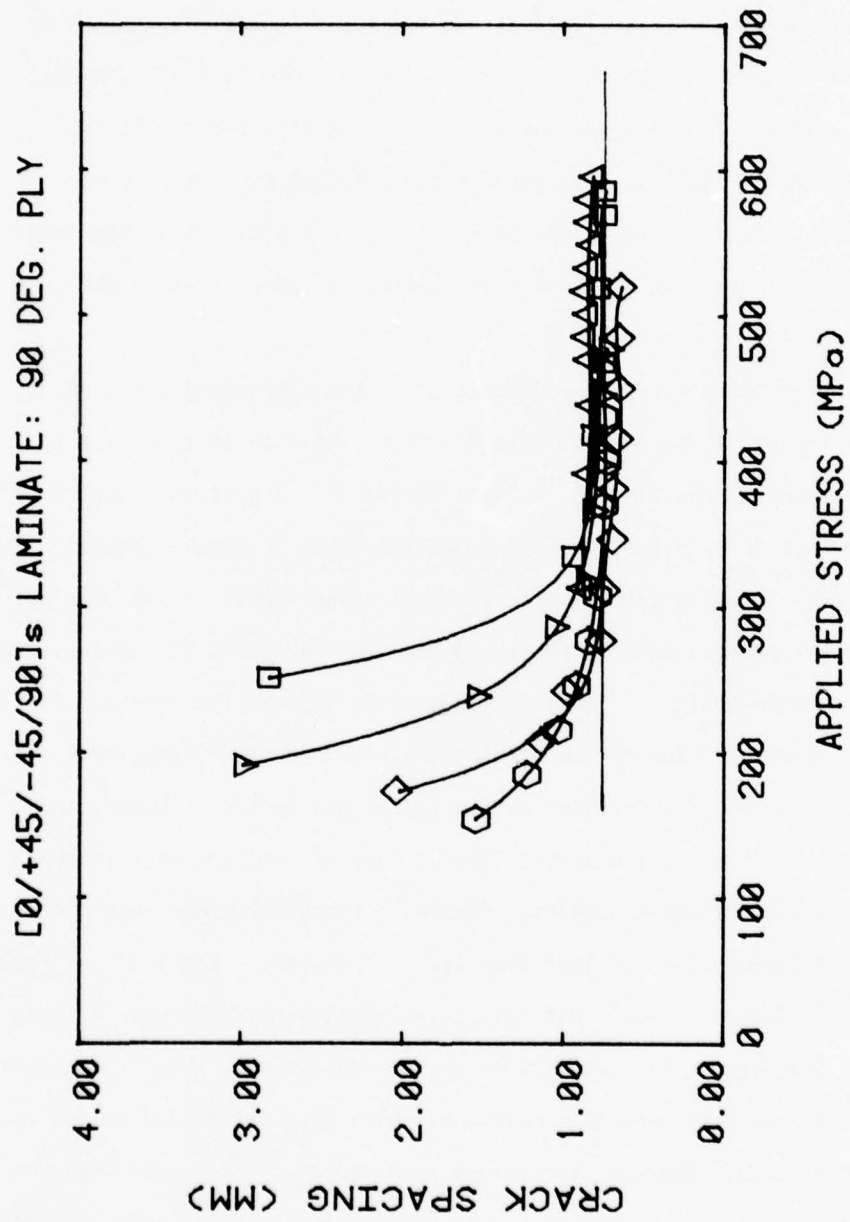
To demonstrate the reproducibility of the characteristic damage state, the crack spacing vs applied stress histories of five Type I specimens have been plotted in Figs. 10 and 11. Two of the specimens were tested in load control, the remaining three in stroke control. The horizontal lines in each figure represent values predicted earlier by Reifsnider using a modified Shear-Lag analysis which we will discuss in a subsequent section. Figure 10 illustrates the results obtained for the  $90^\circ$  laminae. Saturation spacing was attained in all specimens. Although the initial portions of the curves may differ in slope, and values may differ at low stress levels, they all did coalesce to the same approximate crack spacing. Figure 11 shows the crack spacings in the  $-45^\circ$  laminae for the same five Type I specimens. Examination of the data (see Table 1) shows that saturation spacing was achieved in three of the specimens. It could not be stated conclusively that crack spacing values in the remaining two specimens, which were not loaded to failure, had stabilized. However, the values attained at maximum load were comparable to saturation spacing values reached in the other three specimens.

Figure 10. Average Crack Spacings in 90° Laminates for Five Type I Specimens

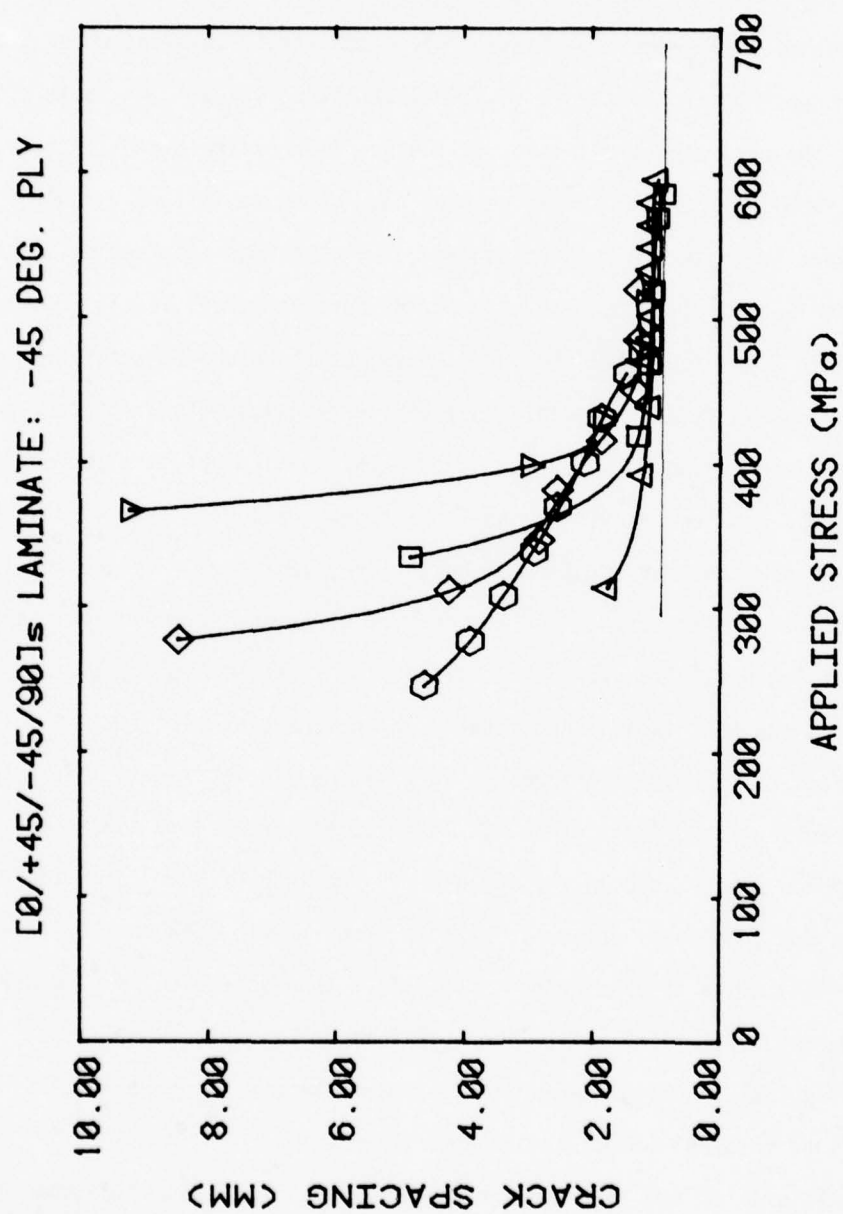
Figure 11. Average Crack Spacings in -45° Laminae for Five Type I Specimens

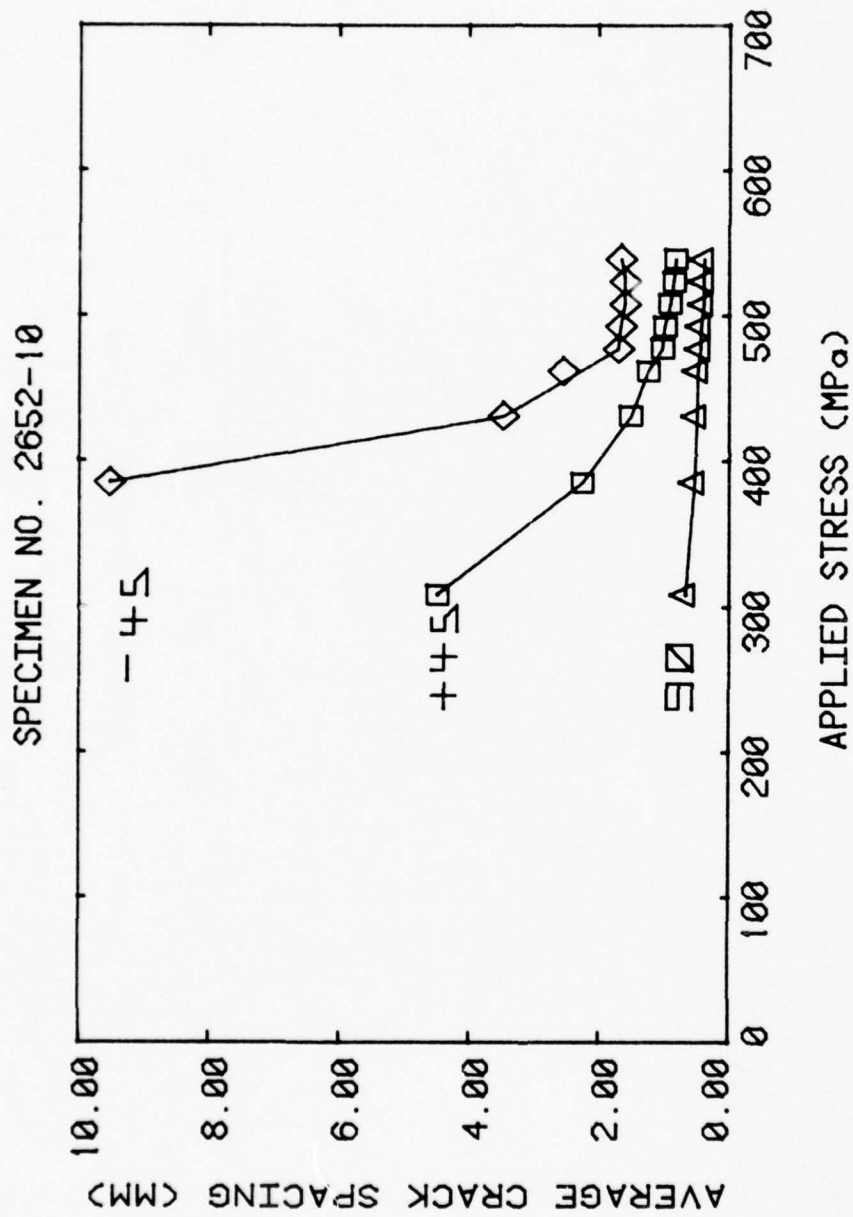
Figure 12. Average Crack Spacings in 90° (bottom), +45° (middle) and -45° (top) Laminæ for Type II Specimen No. 2652-10

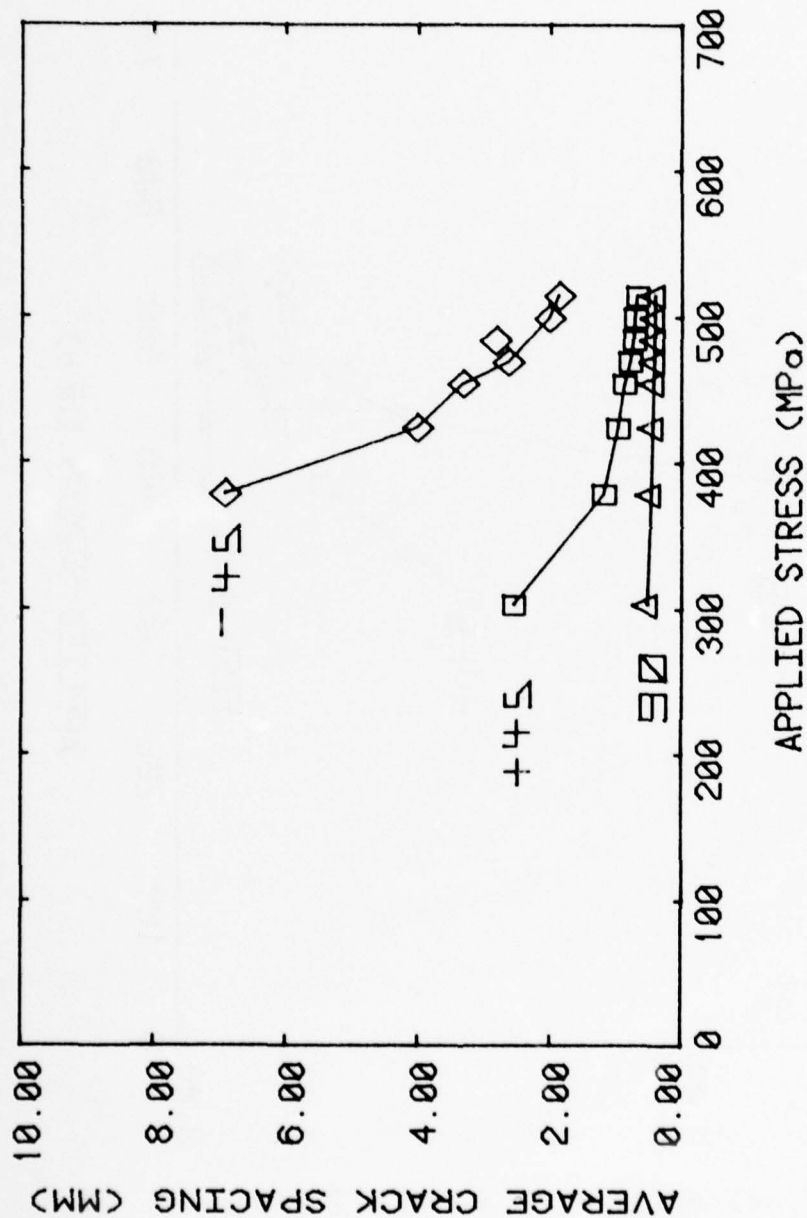
Figure 13. Average Crack Spacings for 90° (bottom), +45° (middle) and -45° (top) Laminæ for Type II Specimen No. 2652-8

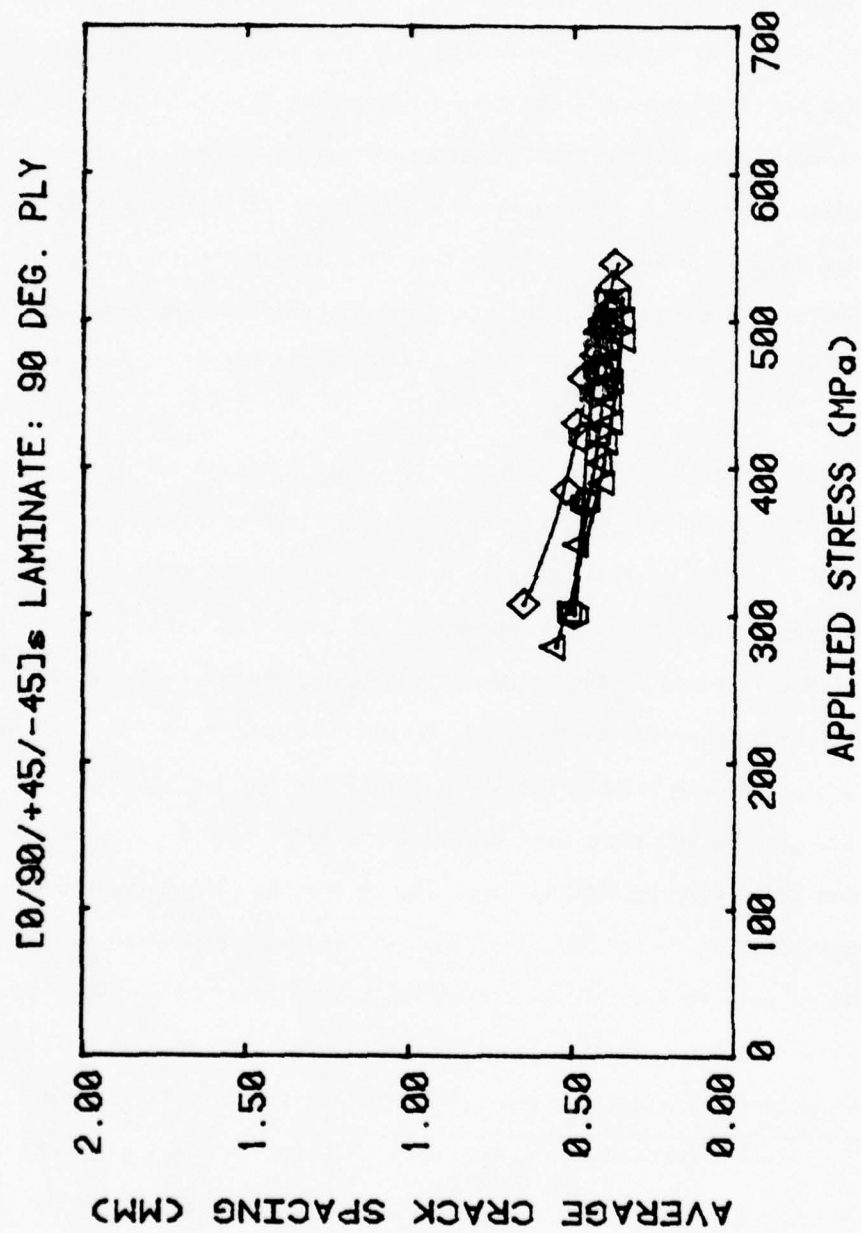
Six Type II specimens were tested to failure. The results of four of these tests were plotted in Figs. 14, 15 and 16. These figures show the crack spacing in the 90°, +45° and -45° laminae respectively. The results of only four of the tests were displayed to simplify the figures. The horizontal lines in each figure represent the predicted values. The figures also demonstrate the consistency of the characteristic saturation spacing values from specimen to specimen. Saturation spacing was achieved by the 90° and +45° laminae in all specimens. It was reached in the -45° laminae of all specimens except 2652-8. Although some variance is

Figure 14. Average Crack Spacing in 90° Laminae for Four Type II Specimens

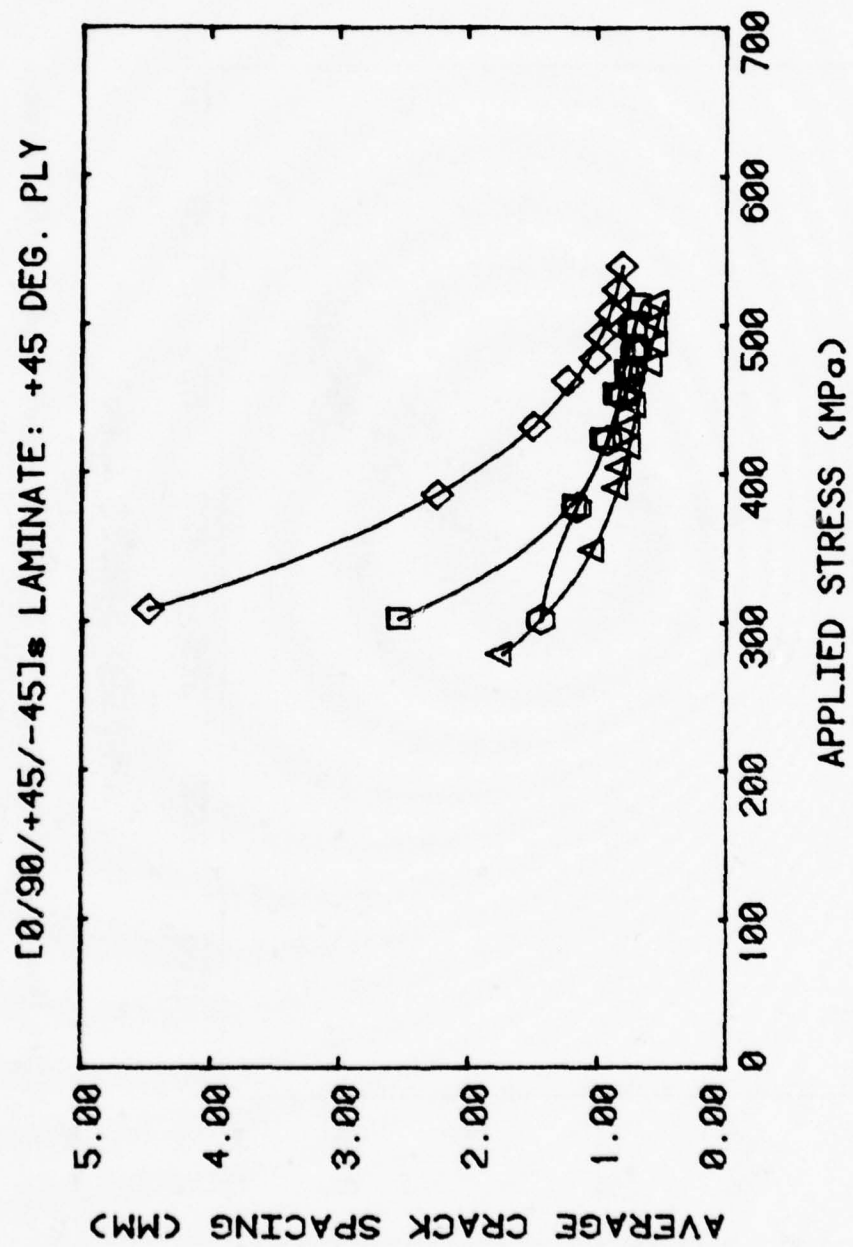
Figure 15. Average Crack Spacings in +45° Laminates for Four Type II Specimens

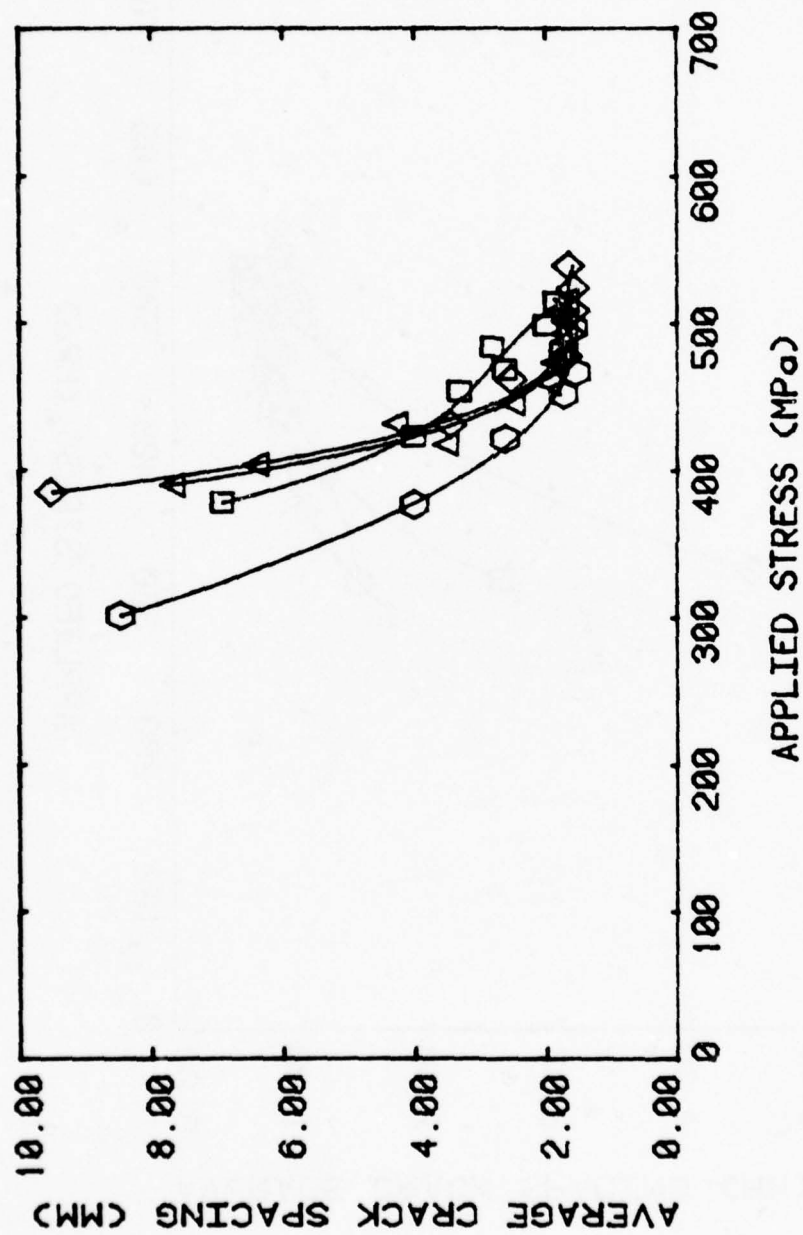
Figure 16. Average Crack Spacings in -45° Laminae for Four Type II Specimens

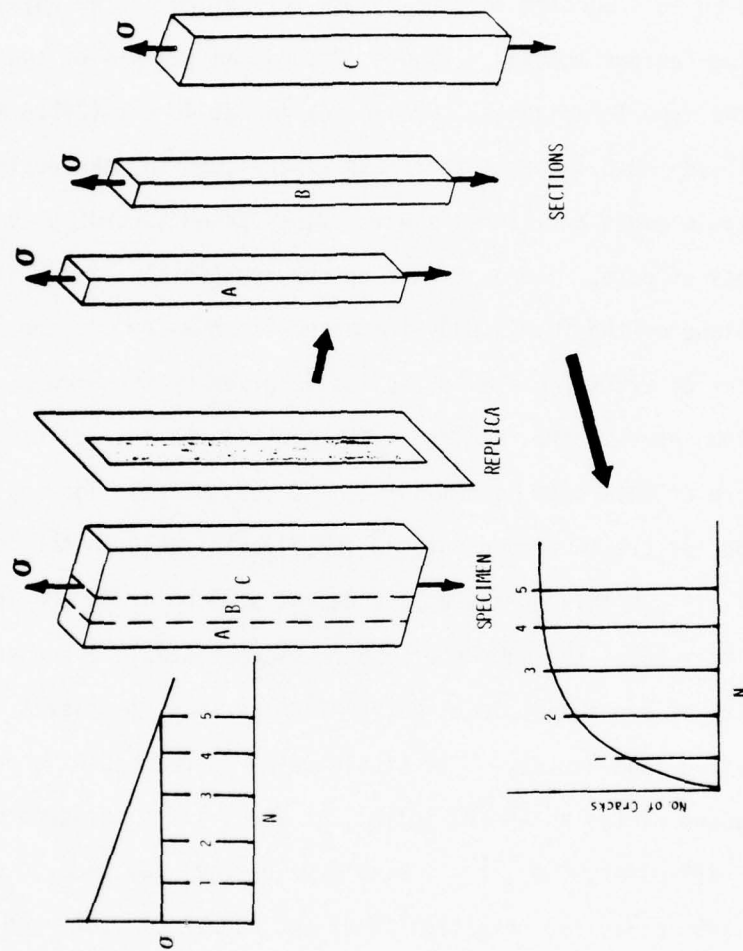
Figure 17. Schematic Diagram of Sectioning and Data Collecting Scheme for Cyclic Testing

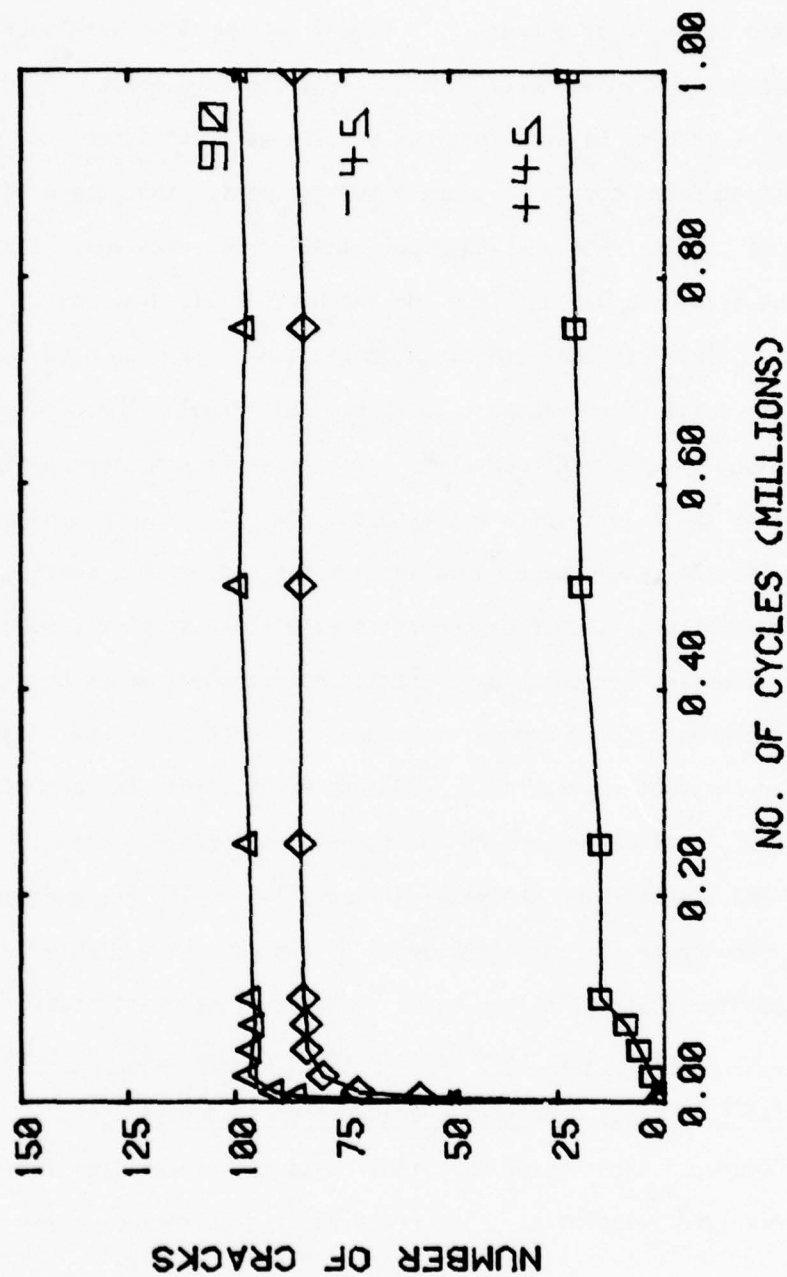
Figure 18. Number of Observed Cracks as a Function of Cycles of Loading at 40 Ksi (275.6 MPa) for Specimen I-15, in the 90° Plies (top curve), -45° Plies (middle curve) and +45° Plies (bottom curve)

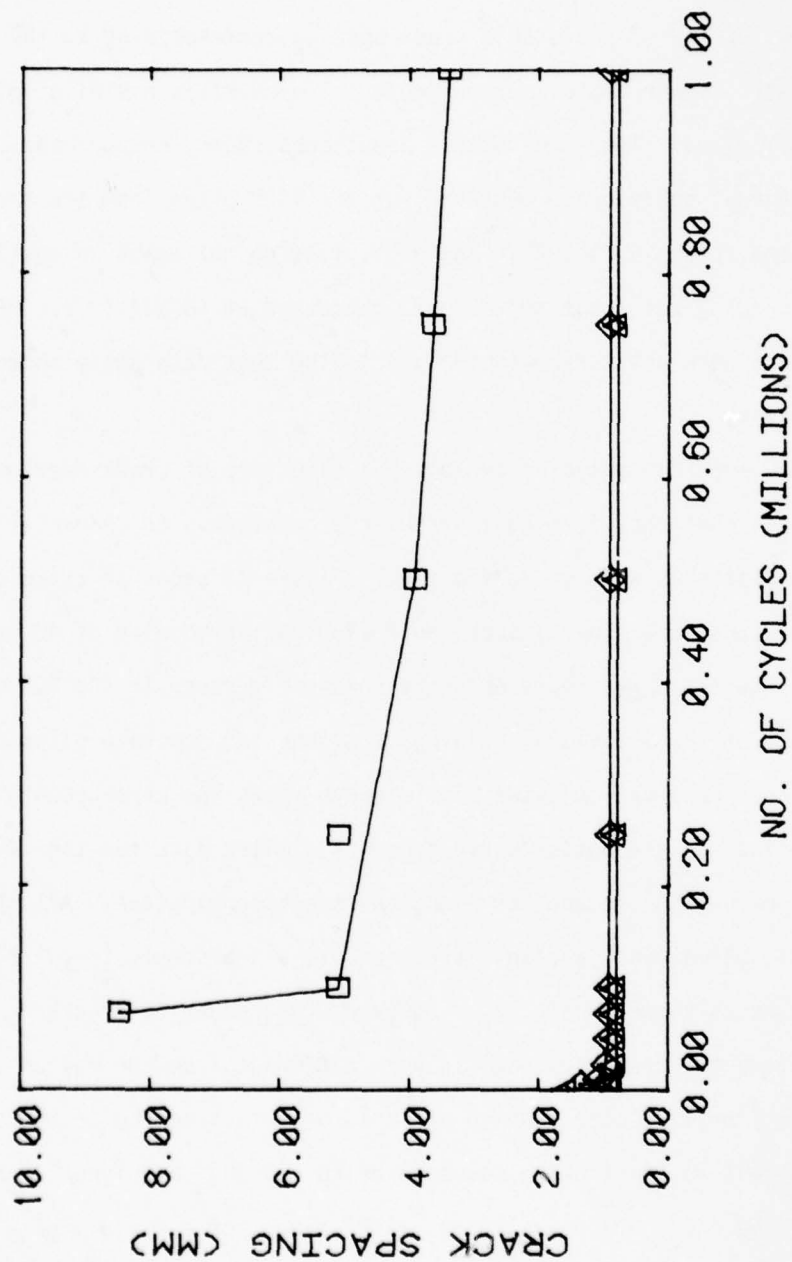
Figure 19. Spacing of Cracks as a Function of Cycles of Loading for Specimen I-15, in the +45° (top), -45° (middle) and 90° (bottom) Plies

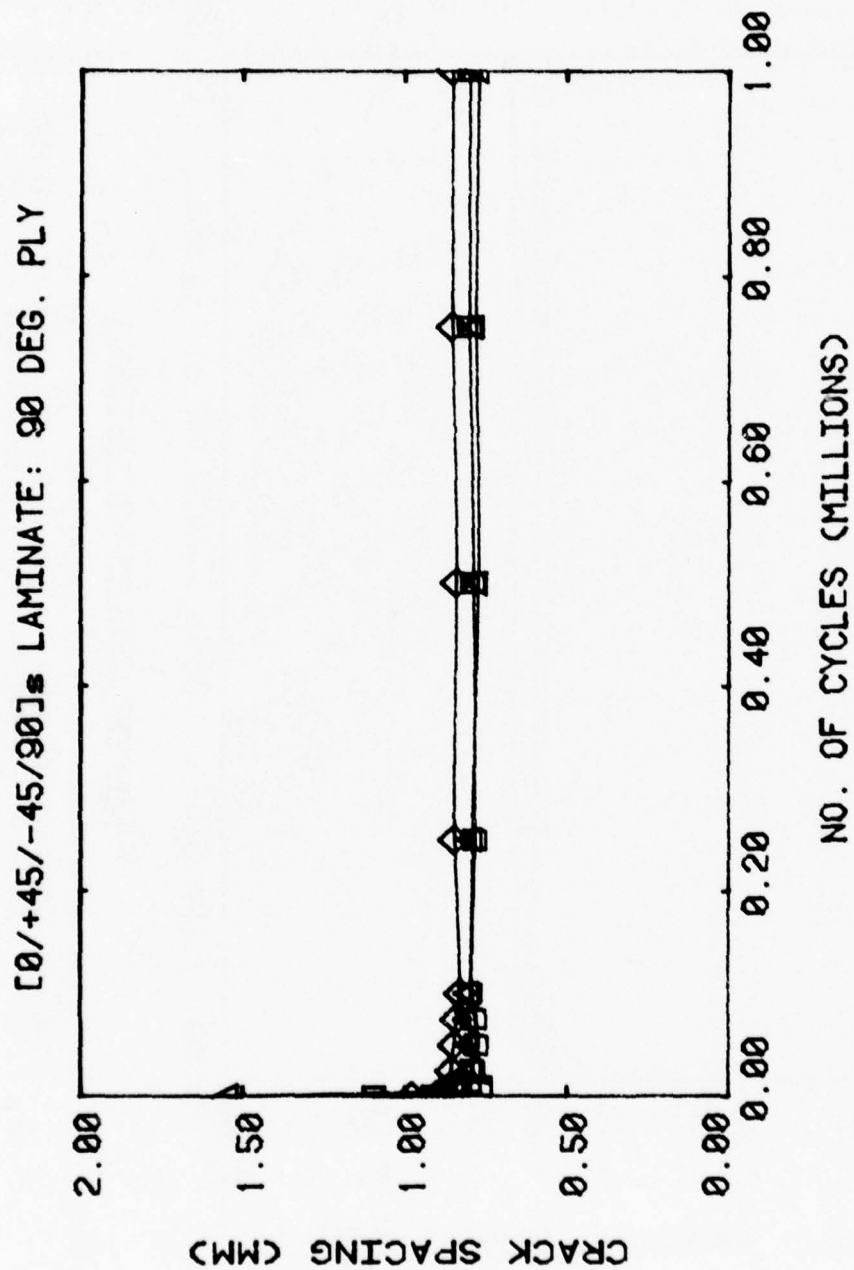
Figure 20. Crack Spacings as a Function of Cycles of Loading at 40 ksi (275.6 MPa) in the 90° Plies of Several Type I Laminates

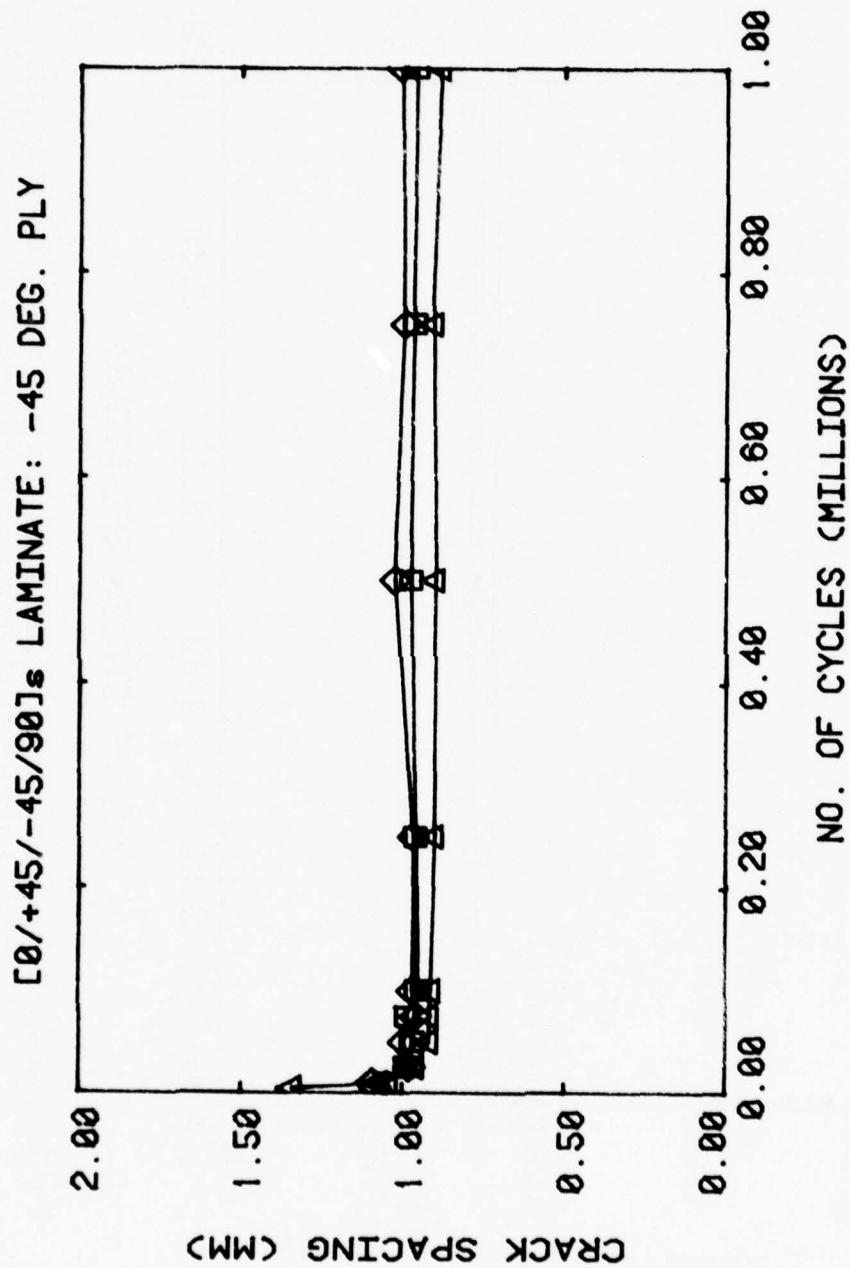
Figure 21. Crack Spacings as a Function of Cycles of Loading at 40 ksi (275.6 MPa) in the -45° Plies of Several Type I Laminates
